JAPANESE MEDICAL EQUIPMENT 260936

FILTER, WATER, FIELD, FOR HOSPITAL USE

REPORT NO. 186

12 March 1946

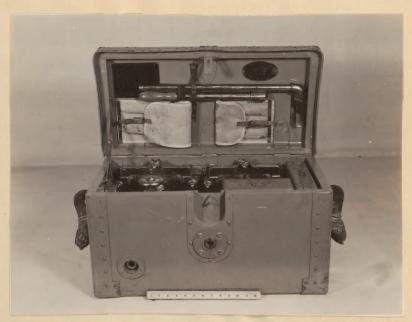
Fig. 1 - Apparatus in chest, as carried and operated.

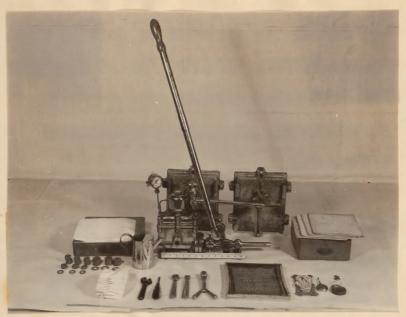
Fig. 2 - Apparatus removed from chest to show details.
